U.S. Coast Guard Research and Development Center

Report No. CG-D-05-03

Cape Henry Lighthouse Fuel Cell Evaluation

**FINAL REPORT
March 2003**

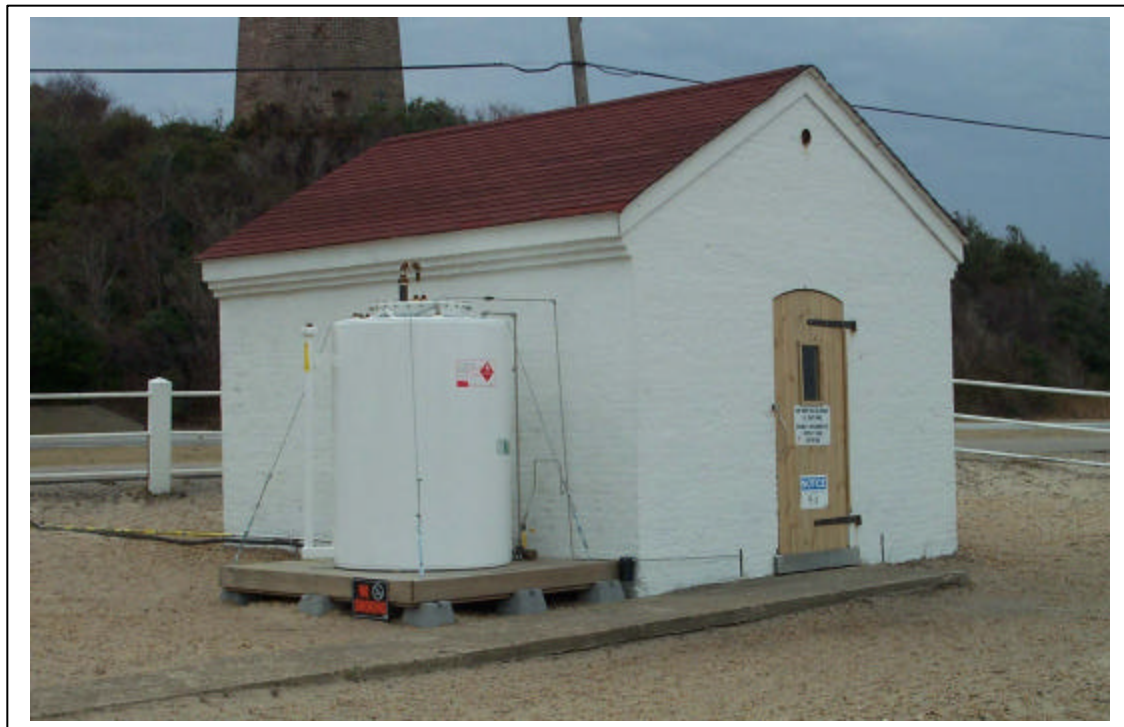
To prepare the site for the installation, a telephone line was installed to the building. This line would provide the electronic access to the site for monitoring by the USCG R&D Center and Fuel Cell Energy personnel. A deck was constructed to hold the 500-gallon fuel tank, and because it is a historical site the front door was replaced with a new door where holes were cut for ventilation and for a window. Once the installation of the fuel tank was completed, a fence was built around the deck with two doors for access and refueling. Figure 2 shows the fuel building housing the fuel cell with the fuel tank and deck as installed.

Figure 2. Cape Henry test site with fuel tank.

USCG personnel prepared the Cape Henry site by running a telephone line into the building, and a deck was built outside the building to support the 500-gallon fuel tank. The tank was delivered and pressure tested to check the double wall containment. It should be noted that the building is considered a historic site so no permanent changes could be made to the structure.

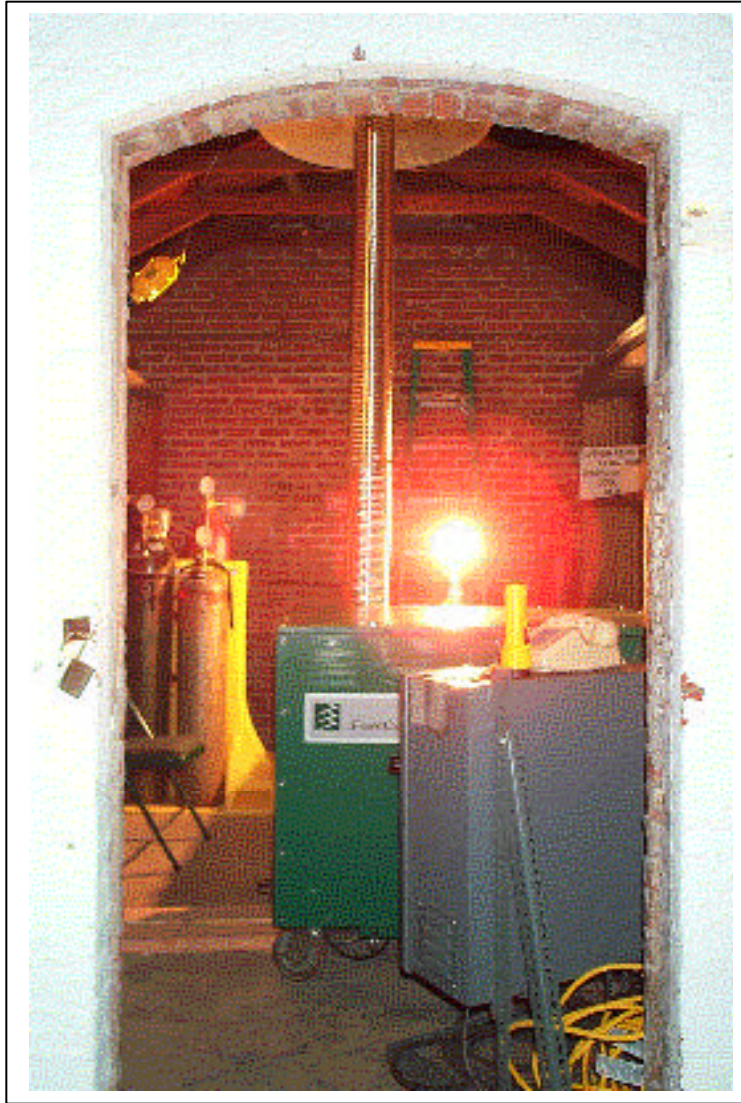
Figure 6. The fuel cell and 1000 watt lamp in the oil building.

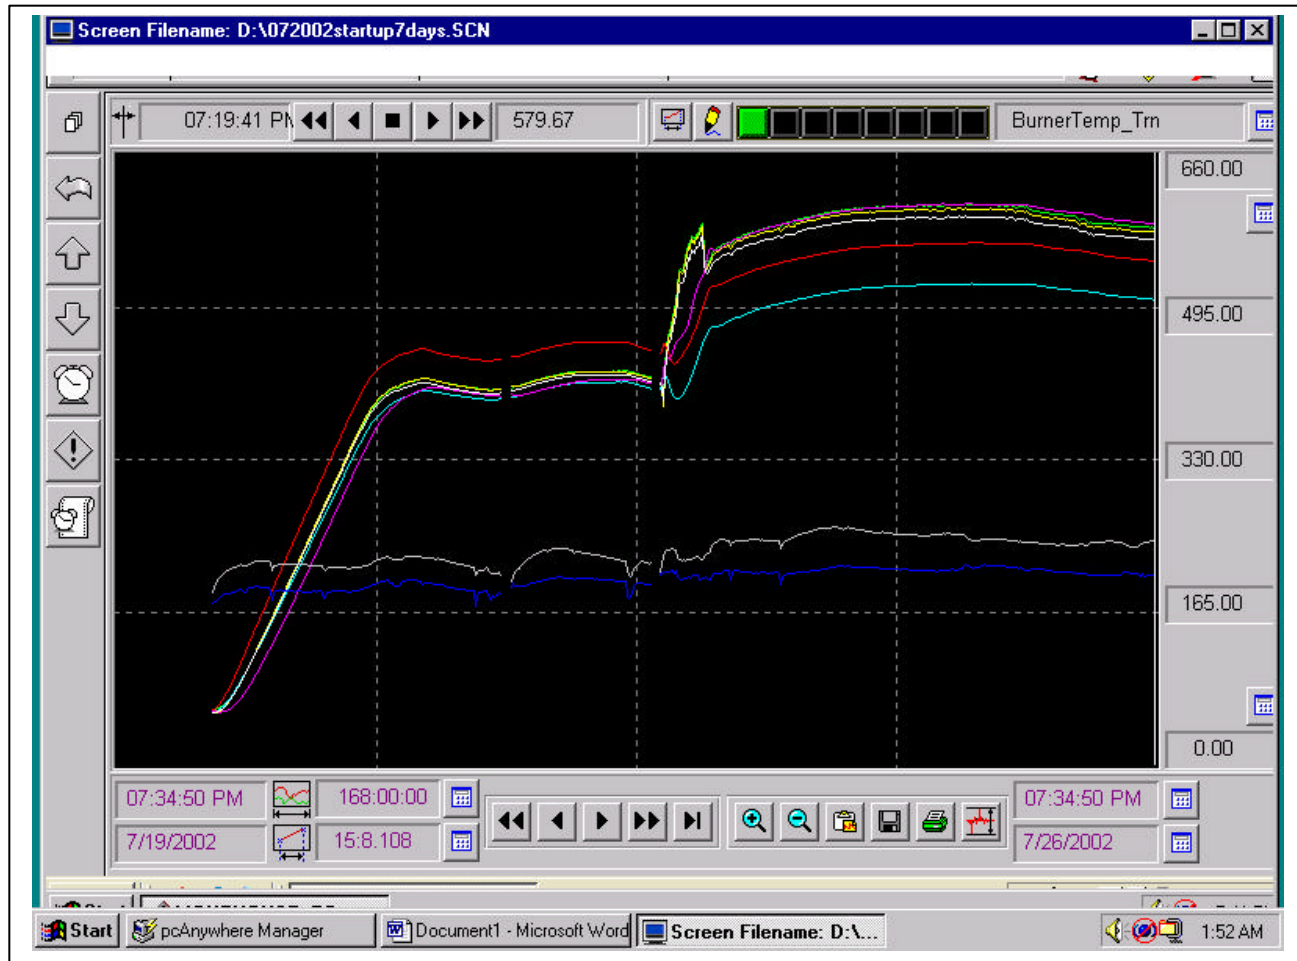
During the five-day on-site test, various temperatures were monitored using an automated data acquisition system (DAS). The main temperature monitored during normal operation is the burner temperature, shown in green on figure 7. Control of the fuel cell, once automatic operation has begun, centers on a burner temperature of 610 °C. The automatic control system keeps the burner temperature at or about 610 °C by adjusting fuel flow through the fuel injector. Figure 7 shows the format of the computer 'Cell Trends' screen available on site and remotely. The screen is a plot of time vs temperature.

Figure 7. Fuel cell temperatures during startup.

Three temperatures are monitored during this final warm-up process, the burner temperature, and thermocouples labeled #18k and #190. The fuel cell must be warmed up at a rate not to exceed 25 °C/hour and not to exceed a temperature differential across the fuel cell of more than 50 °C. to avoid excessive thermal expansion. These temperatures are controlled by the fuel flow, and regulated by the knob on the flow meter. The system cannot be left unattended during this part of the warm-up.

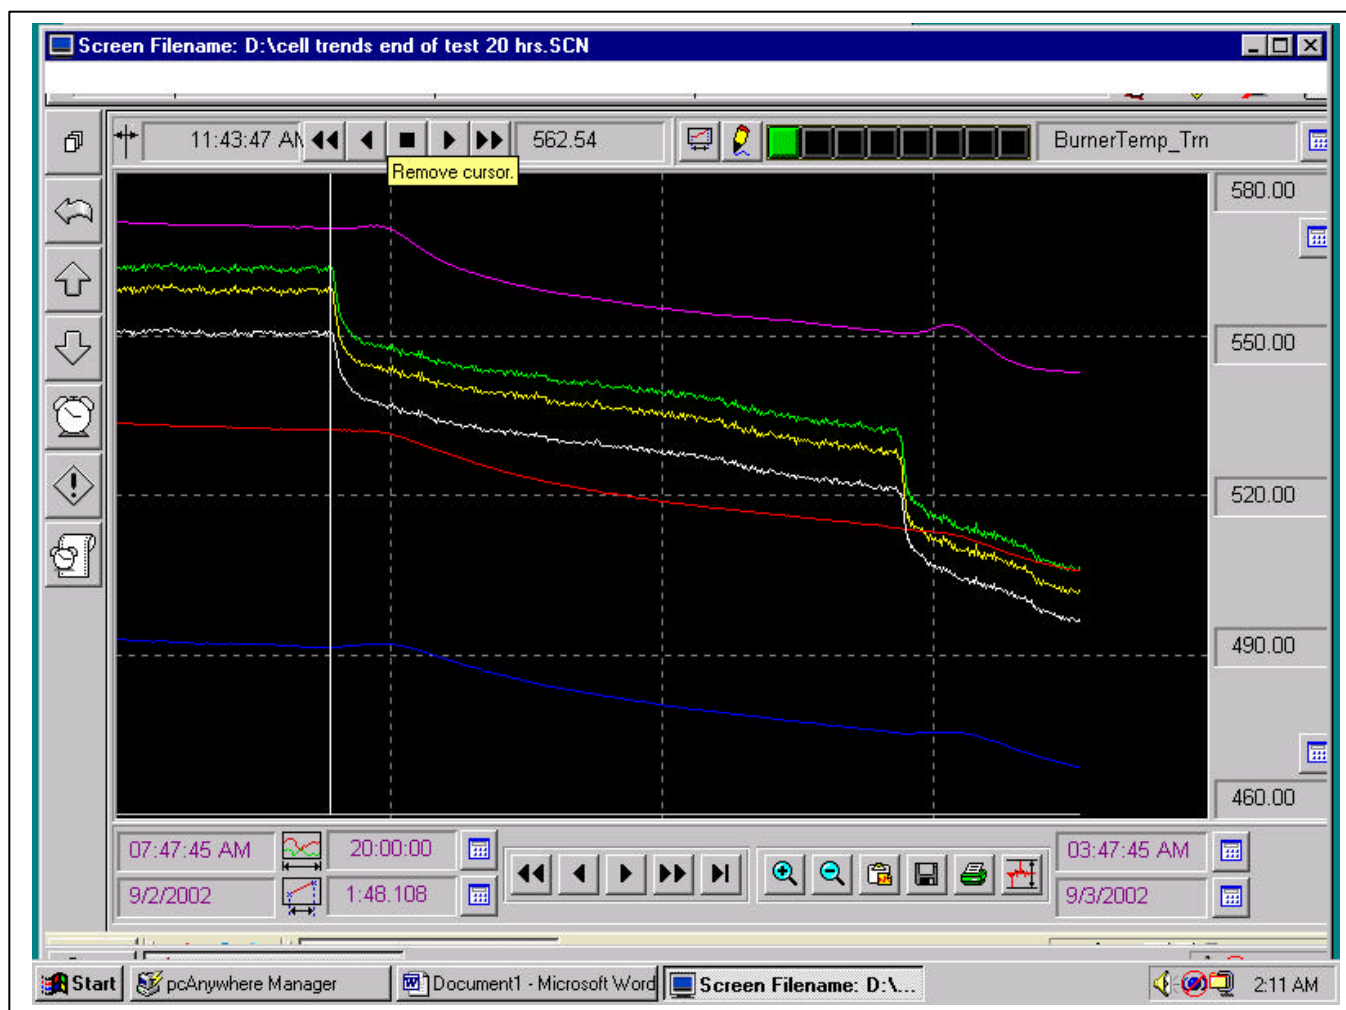
During the six-month operation of this test system, many outages were experienced. Initially there were multiple problems with the fuel mixture and bubbles within the fuel lines created by the daily heating and cooling of the fuel lines from the storage tank to the fuel cell. In one case, the UPS overheated and shut down due to heat buildup in the building. One of the Programmable Logic Controllers overheated and caused a shut down of the system. One failure was caused by a fuel injector failure in the system. There were two instances of operator errors. All of these failures were overcome and corrected; many were growing pains of a prototype system of new technology. A complete description of these failures can be found in Appendix E. Figure 11 is a screen print showing a low temperature system failure, like that of the fuel injector failure. In all cases, the remote DAS enabled both FCE and the USCG to diagnose problems and expedite corrective action.

Figure 11. Low temperature shutdown plot.
